Technical Report ARAED-TR-93004

**XM898 PROJECTILE 155-mm SADARM PACKAGING
DESIGN AND ENGINEERING TEST REPORT**

Mark P. Nitzsche

April 1993

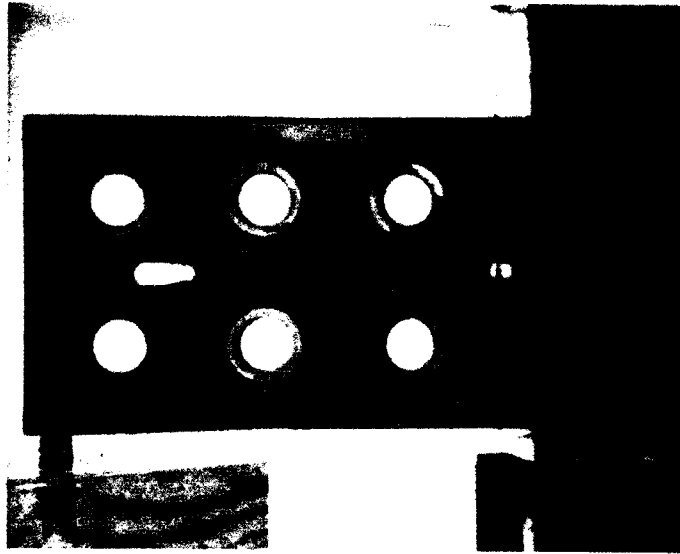
Figure 1. Metal pallet after testing (ambient)

Damage sustained by the metal pallet during secured vibration at ambient was limited to the spacers (P/N 12914692) and the liner covers (P/N 12926863). Some of the tabs on the spacers snapped and became loose. All of the liner covers exhibited some degree of tearing and compression, and the lifting plugs on the projectiles did not maintain the specified torque. Before the secured vibration at +160°F, four of the eight spacers in the pallet were cut at one section. This modification was used during the original pallet qualification testing. For comparison purposes, the four cut spacers were staggered in their placement in the pallet base. After testing it was noted that only the tabs on the spacers which were not cut sustained damage. Again, all the liner covers exhibited some degree of tearing and compression, and the lifting plugs loosened.

The cumulative effect of the secured vibration testing on the metal pallet was that a small (< 1/4 in.) amount of clearance was created between the portion of the projectile lifting plug upon which the cover of the pallet rests and the cover assembly (P/N 12914624). This occurred at each of the three temperatures, but there was no evidence of damage to the projectiles and the function of the metal pallet was not affected in any way.

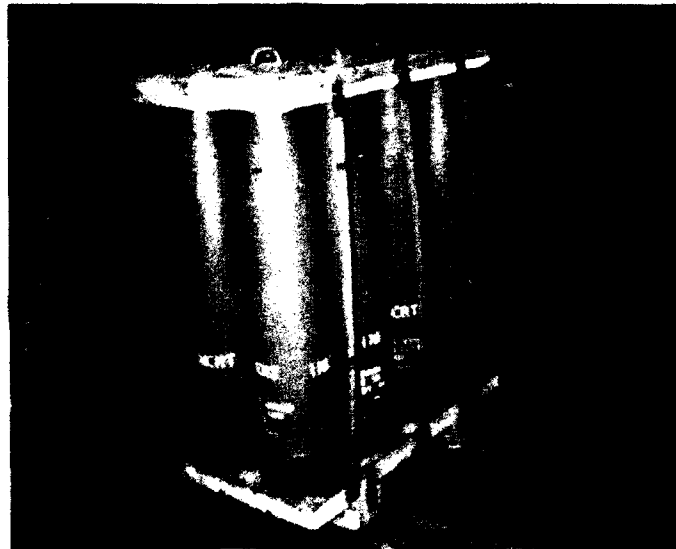
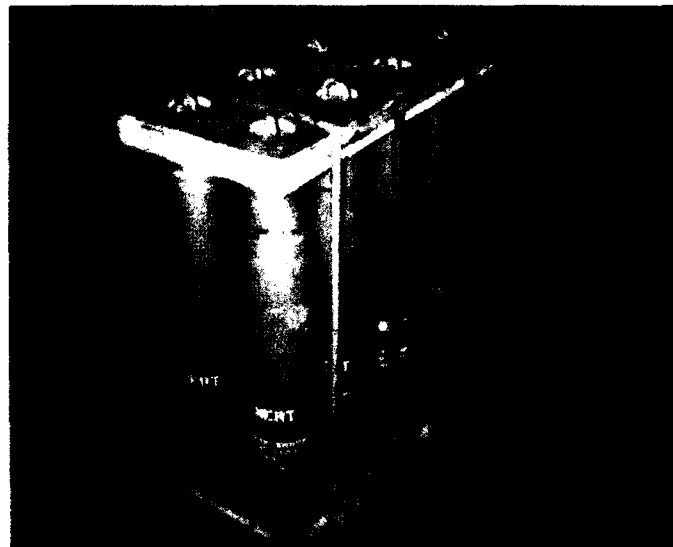
Figure 6. Wood pallet after testing

As previously stated, the wood pallet sustained severe damage during secured vibration in the vertical axis at ambient. This testing was done in accordance with the schedule originally required by the test plan. No problems were encountered during vibration in the longitudinal and transverse directions. However, while testing in the vertical axis several of the projectiles broke through the pallet cover. In addition, the pallet base was severely splintered.

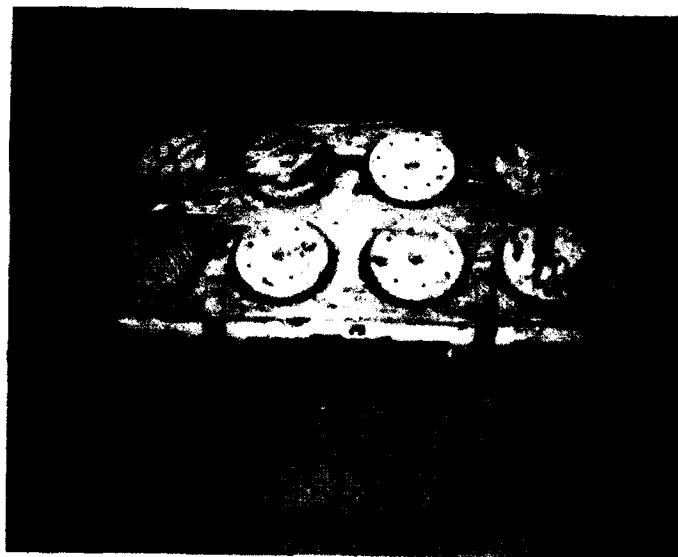
Figure 7. Wood pallet base after testing

During secured vibration testing at -65°F, the bottom rims of the projectiles again cut into the base of the wood pallet. However, the depths of the grooves were only about 1/8 in., and there remained substantial clearance (approximately 1/2 in.) between the grommets and the pallet base. The other damage sustained by the wood pallet was in the cover. One lifting plug hole was elongated and another splintered in the area of the chamfer. At the completion of secured vibration at -65°F, there was no evidence of damage to the projectiles, and they remained consolidated in the wood pallet.

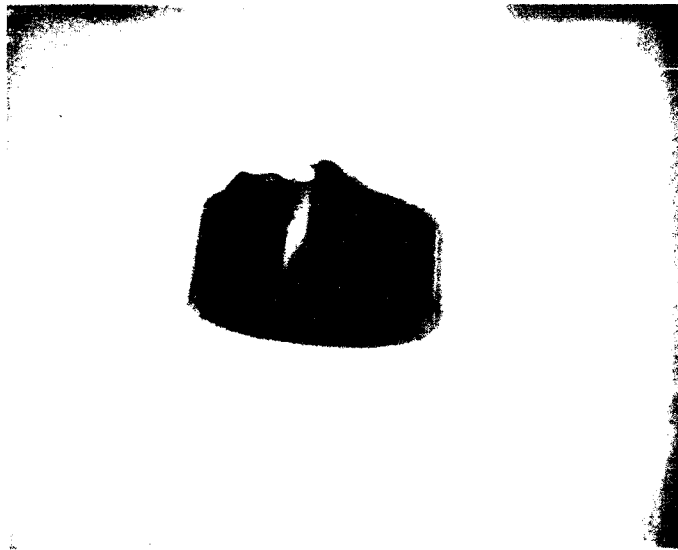
The test projectiles employed were inert XM898 projectiles, each containing two mass models. The grommet employed was P/N 9321436, the same as that used on the M864 projectile. Due to the fact that the rotating band is closer to the end of the XM898 projectile than other projectiles which use this grommet, an interference resulted. The grommet contacted the base of both the wood and metal pallets before

the projectile was completely seated in the pallet. This interference necessitated a modification to the grommet. The lower tab on the grommet was removed, and the lower loop of the grommet fastener was reformed to reduce its diameter (fig. 13). In testing the wood pallet, the interference problem became more severe. The modified grommet was not sufficient, and further modification to the pallet was required. Wood plugs were designed and inserted in the openings in the base of the pallet to eliminate further interference problems. Use of these plugs created a clearance which was great enough to allow use of a standard unmodified grommet.

Figure 13. Modified grommet

Further testing is required on the modified grommet before it can be approved for use on the XM898 projectile outside the pallet. However, the modified grommet functioned successfully during pallet testing and is, therefore, approved for use in the palletized configuration using both the metal and wood pallets.

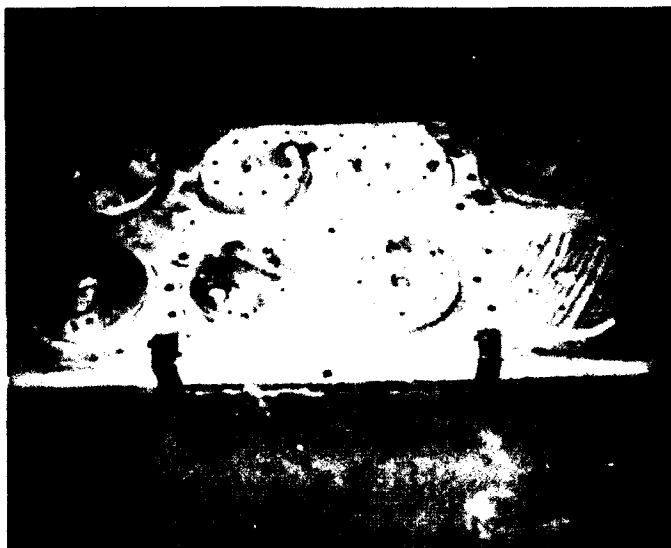
The test was then repeated at ambient with a new pallet using the same vibration schedule as that employed for the metal pallet. During this secured vibration test sequence, grooves up to 1/2 in. deep were formed in each of the cutouts in the pallet base. These grooves were formed by the bottom rim of the projectile base assembly, which is thinner than those currently used. The rim cut into the wood of the pallet base as the projectiles rotated. These grooves resulted in the projectiles sitting lower in the pallet base, and contact being made between the modified grommets and the pallet base. In one case, a grommet was forced up, severing an obturator band. No other damage to the projectiles was noted. To eliminate this interference problem, modification to the wood pallet was required. Wood plugs consisting of two different diameter disks of 3/4 in. plywood were constructed (glued and nailed together). The larger disk fits in the cutout in the pallet base and the smaller disk fits inside the bottom

rim of the projectile base assembly. The projectiles, therefore, rest on a solid plywood surface which helps prevent a groove from being formed. In addition, the height provided by the larger disk eliminates the need to use a modified grommet (figs. 16 and 16).

Figure 16. Wood pallet base modified with disks

The first test sequence (ambient) proved that some modification, in addition to the modified grommet, was required for the wood pallet to be used with the SADARM projectile. In subsequent testing, this modification, the use of wood plugs, maintained its integrity and performed its function in preventing the grommet from contacting the pallet base.

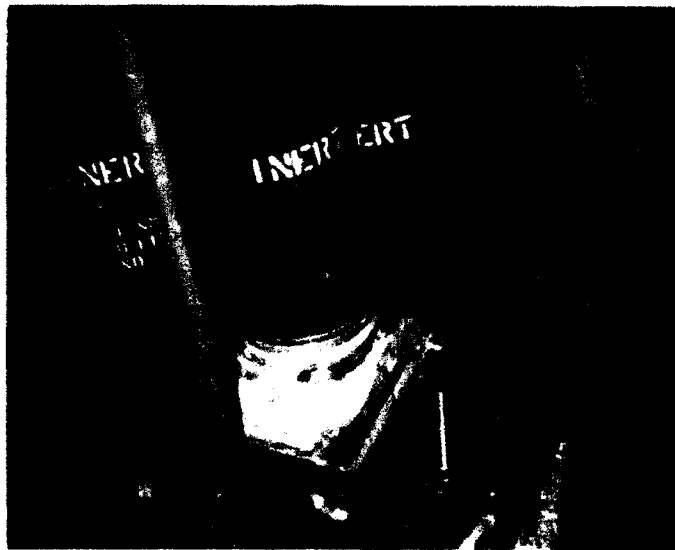
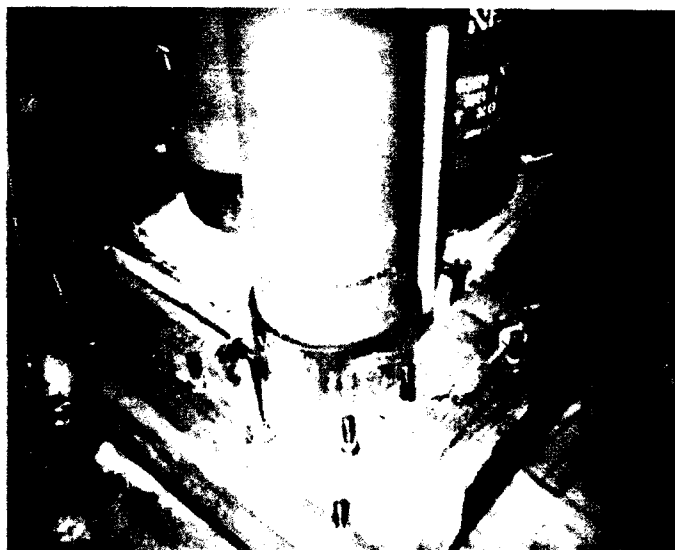
A new wood pallet was modified using the wood plugs and then subjected to secured vibration testing at +160°F. No damage was noted after testing in the horizontal and transverse directions. However, during testing in the vertical axis one of the projectiles broke through the holes in the pallet cover. As a result the projectile came out of the pallet base (figs. 17 and 18). In addition to the enlarged hole in the pallet cover, splintering and splitting of the wood around the other holes in the pallet cover and the pallet base occurred. Two grommet wires were bent, with one of the grommets coming open. There was no evidence of damage to the projectiles. However, the extent of damage sustained by the pallet prevented the +160°F test sequence from continuing. Upon further inspection it was noted that the wood covers of the test pallets were improperly constructed. On the underside of the plywood there were counterbores up to approximately 1/8 in. deep. These counterbores are not in accordance with the wood pallet drawing. The resulting weakening of the plywood appears to have been the cause of the pallet failure during the initial secured vibration testing at ambient and the secured vibration testing at +160°F. Due to a shortage of available pallets and the questionable manufacture of those available, the +160°F test sequence was not concluded.

Figure 18. Wood pallet secured vibration test (+160°F)

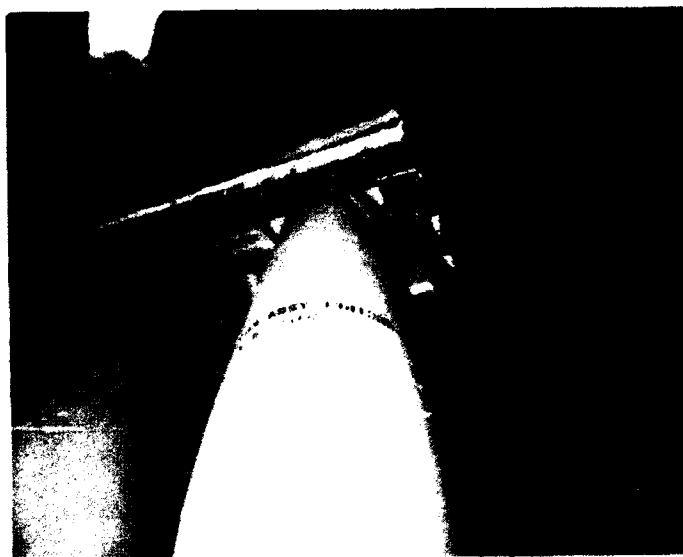
The damage sustained by the metal pallet during loose cargo testing at ambient and at +160°F was similar to that produced by the secured vibration testing. Again, there was no evidence of damage to the projectiles and the function of the metal pallet was not affected in any way (fig. 19).

Figure 19. Metal pallet after loose cargo test

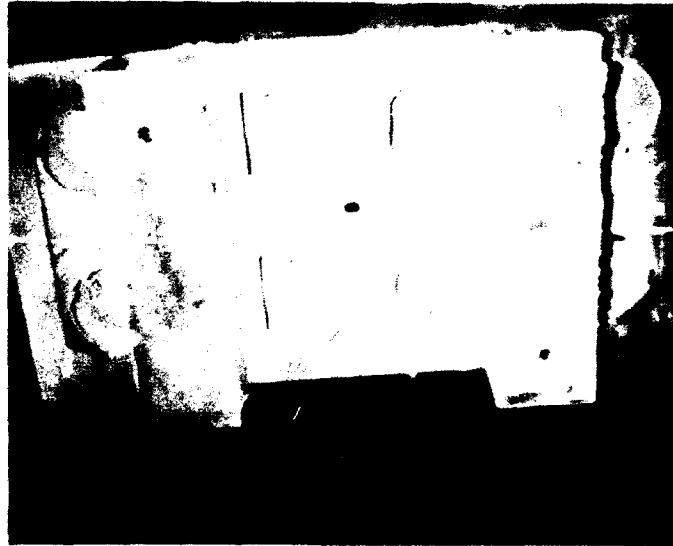
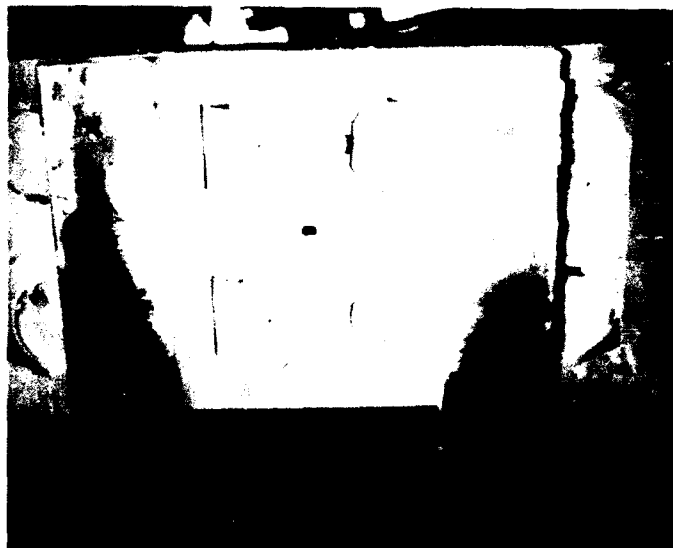
The metal pallet experienced considerable damage during loose cargo testing at -65°F. All of the cover liners were severely damaged, and the spacers shattered. In addition, the destruction of the spacers caused the projectiles to drop and there was contact between the pallet base and the four outer grommets. All four of these grommets displayed wear from the contact with the pallet. In one instance, the contact forced the grommet up slightly, severing the obturator band (fig. 20). Despite the damage to the pallet, however, the projectiles remained consolidated within the pallet and testing was able to continue (fig. 21).

Figure 21. Metal pallet after loose cargo test (-65°F)

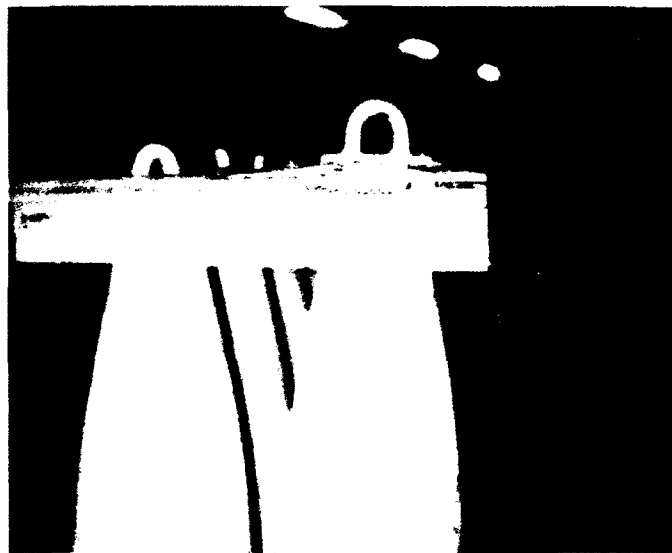
At ambient, the wood pallet sustained only minor splintering as a result of the edgewise drops. At -65°F the cover sustained slight separation of the plywood layers in the area where the edge of the cover struck the ground. There was no evidence of damage to the projectiles as a result of the edgewise drop test.

At ambient, the wood pallet sustained only minor splintering as a result of the cornerwise drops. During the first cornerwise drop at -65°F, the plywood separation which occurred during the edgewise drop became more severe. While the pallet was being hoisted upright in preparation for the second cornerwise drop at -65°F, one of the lifting plugs, which still secure to the projectile, broke through the pallet cover. The hole which the lifting plug broke through was the one which was elongated during secured vibration near one of the areas which had sustained separation of the plywood layers. As a result of this damage, testing could not continue (fig. 22). Therefore, the pallet cover was removed and replaced with the cover which had gone through the entire test sequence at ambient. During the second cornerwise drop, however, the projectile at the corner on which the pallet was being dropped again broke through the cover. In this instance, the base of the projectile dislodged from the base of the pallet (fig. 23). The cause of failure again appeared to be separation of the layers of wood in the plywood cover piece. Despite the cover failures, the only damage sustained by the item (grommet) was that the plastic tabs which hold the wire were broken off when the projectile came out of the pallet. However, the grommet remained in place. Aside from moderate splintering of the pallet base and the wood plug for the projectile which became dislodged, there was no evidence of damage to the projectiles. Following the second cornerwise drop, the cover of the pallet was again replaced so that testing could continue.

Figure 22. Wood pallet cover after 1st cornerwise drop (-65°F)

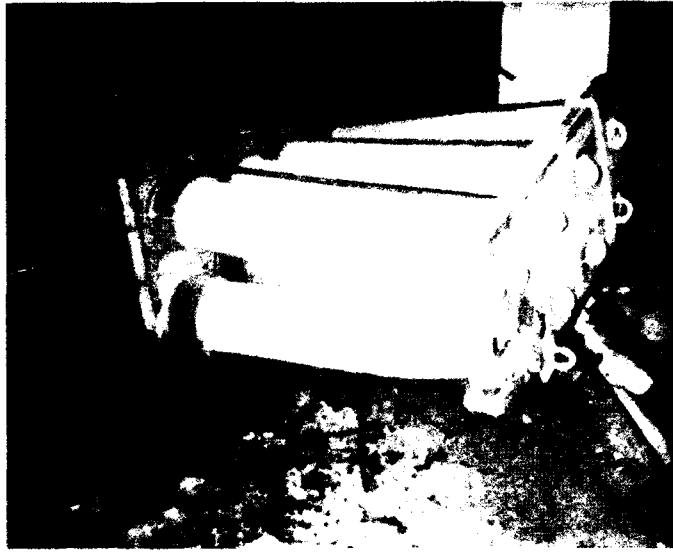
Figure 23. Wood pallet after 2nd cornerwise drop (-65°F)

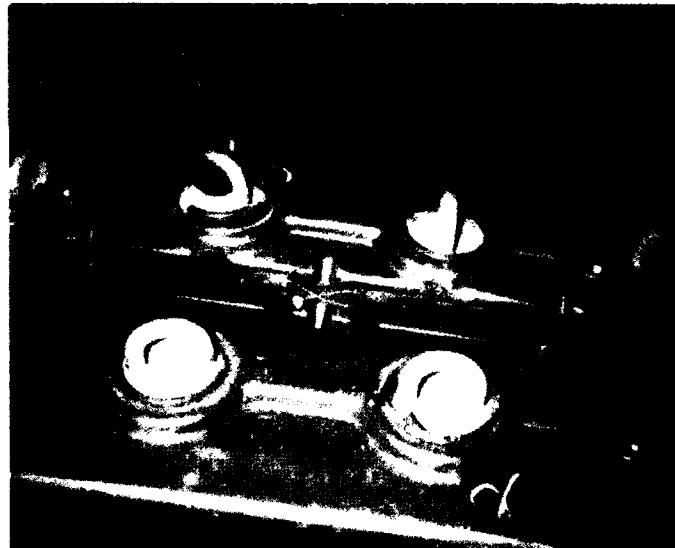
The metal pallet sustained minor bulging of the pallet cover around the hole for the one lifting plug to which the support chain was hooked. There was no effect on the function of the pallet. There was no evidence of damage to the projectiles (fig. 25).

Figure 25. Metal pallet cover after sudden lift test
